Bel Aire Heat Exchanger

Application: *Hot Water heat exchanger*

Unit installed: *S38*

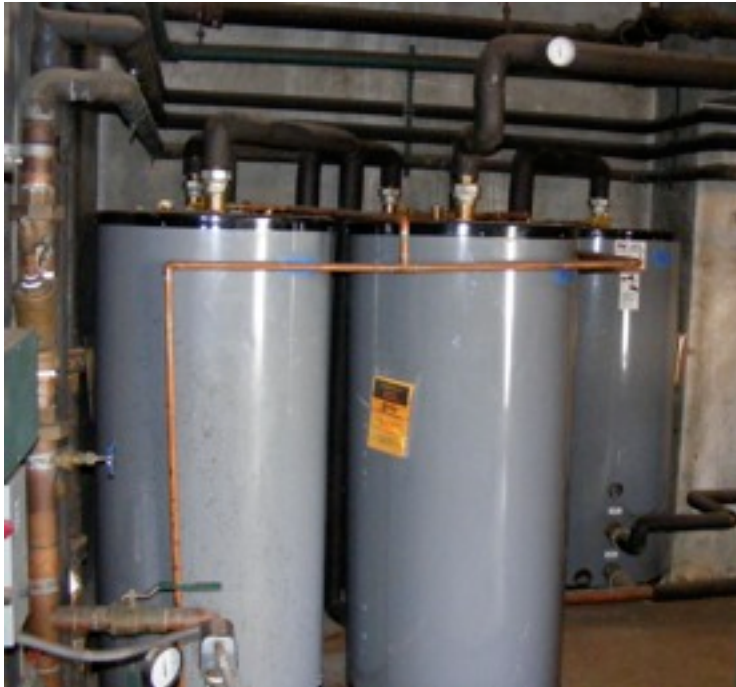
Mechanical room where hot water tanks and heat exchangers are located
