Case Study - Hotel Cooling Tower Scale and Bio

Marriott Koolina Beach Club, Oahu, Hawaii, USA.

500 Ton Cooling Tower.

HydroFLOW Custom 14" water conditioner on a cast iron pipe feeding the chillers.

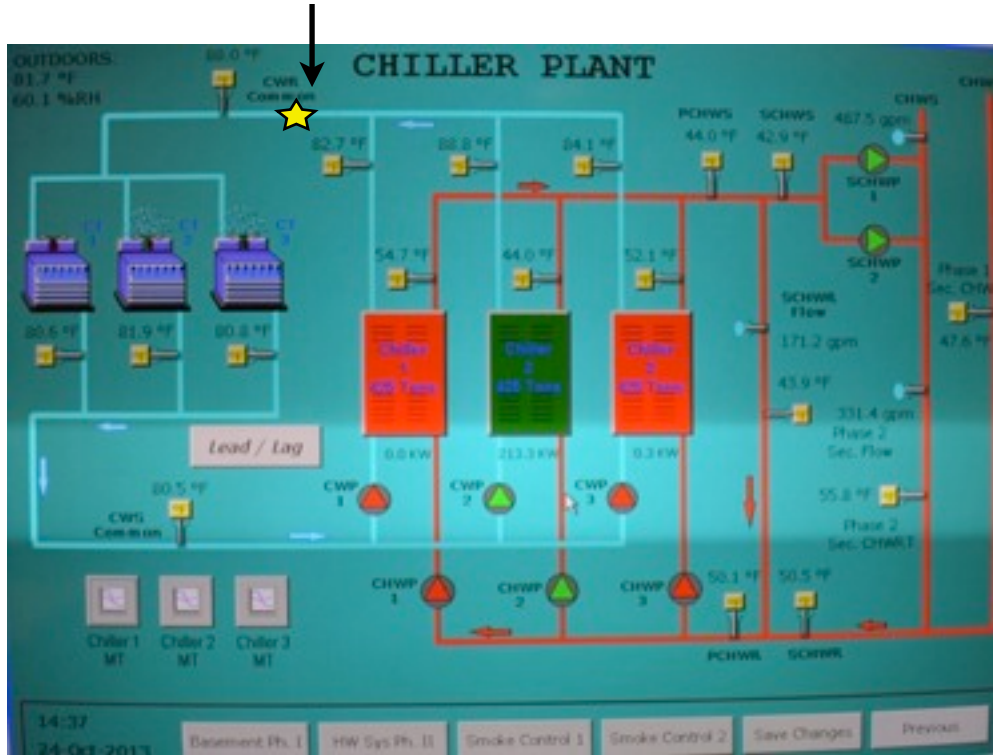
System diagram and installation point:

HydroFLOW Water Conditioner

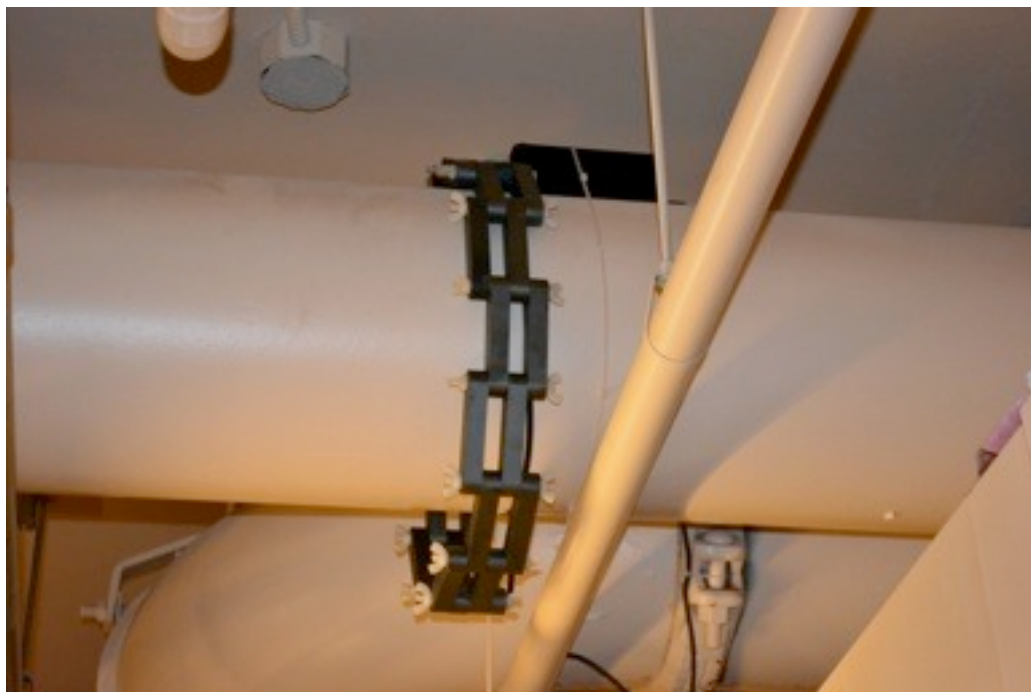
Installed *HydroFLOW* water conditioner:

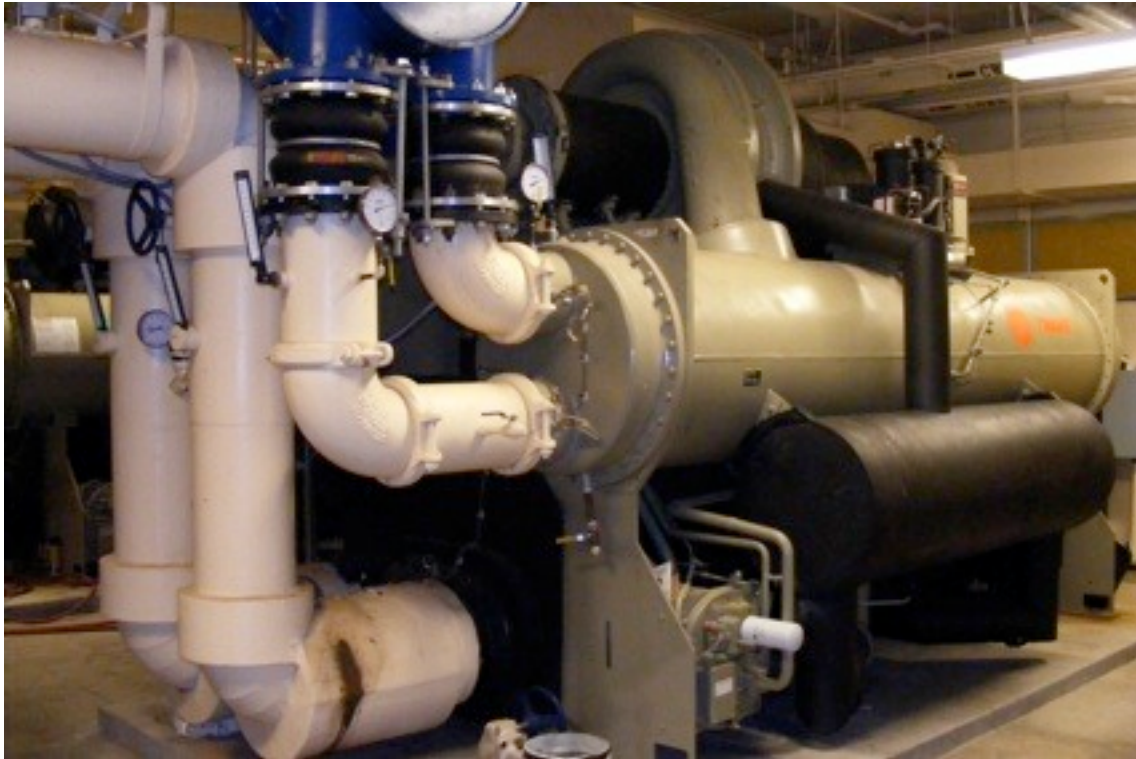
One of the 3 chillers:
