The Waianae Store. Ice Machine

Case study: 165 days

Goal: Significantly reduce scale build up in Ice machine

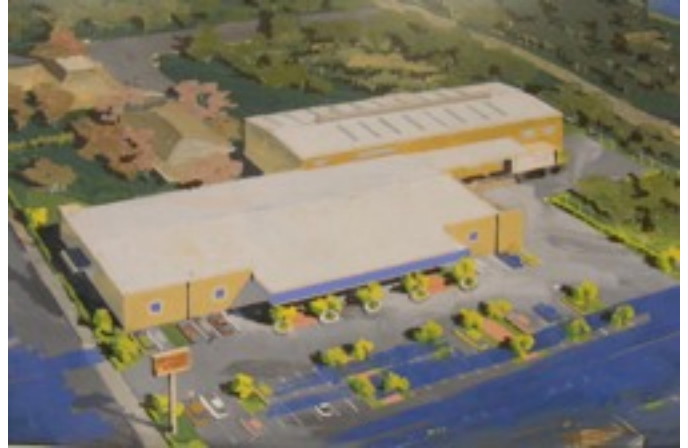
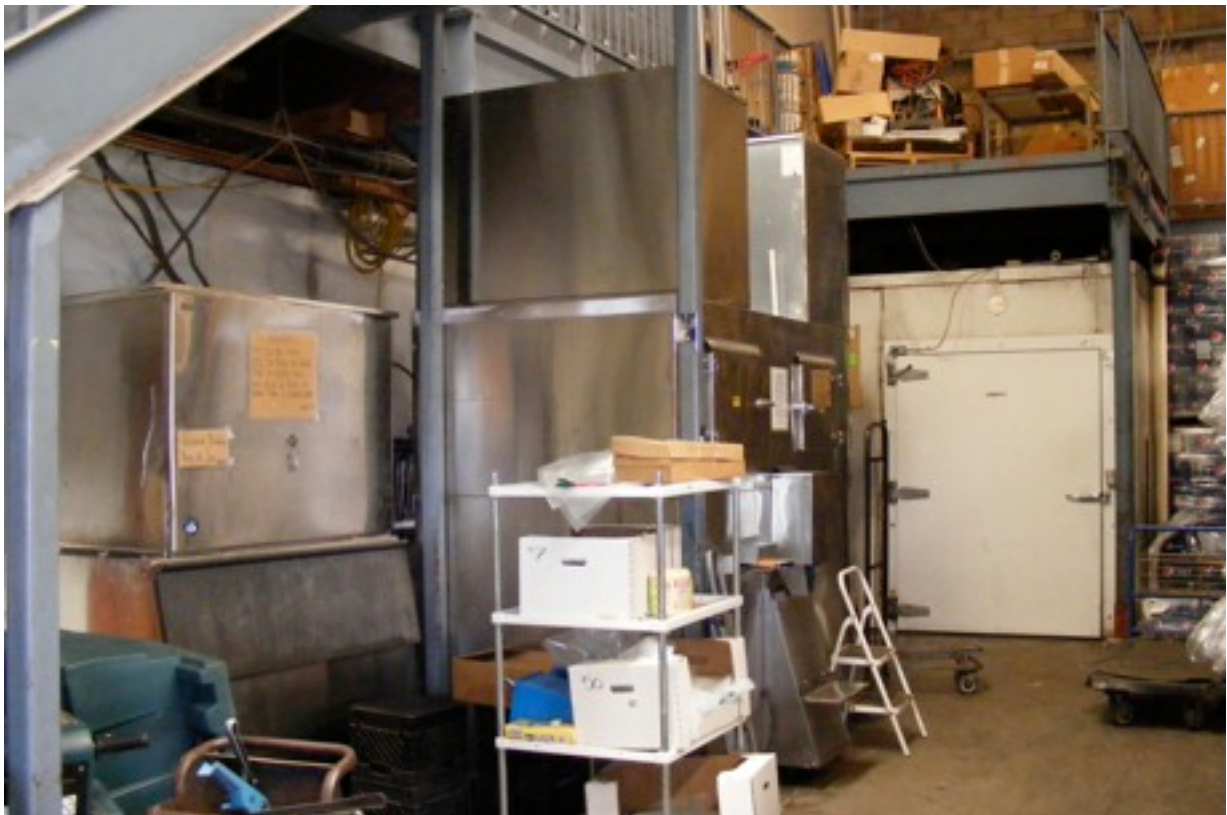
Ice Machine

A S38 water conditioner was installed June 2, 2011.
At which time all filters were shut off

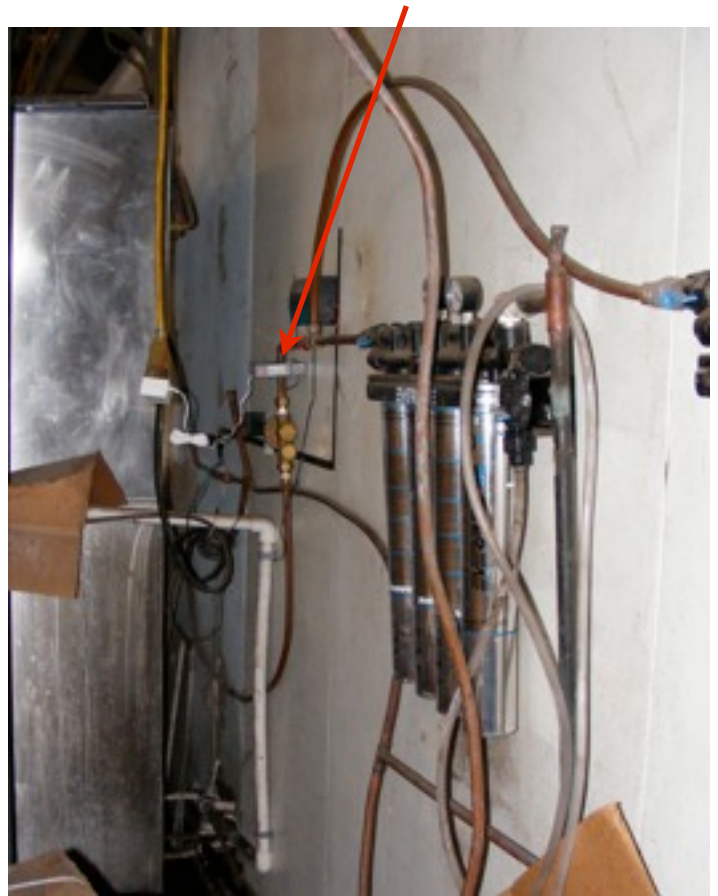
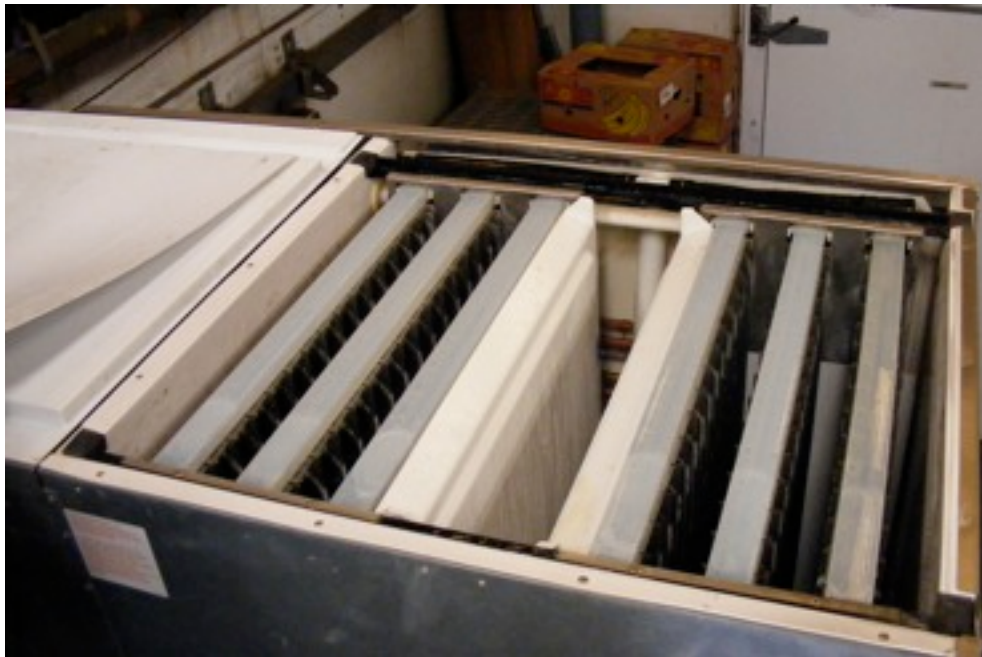
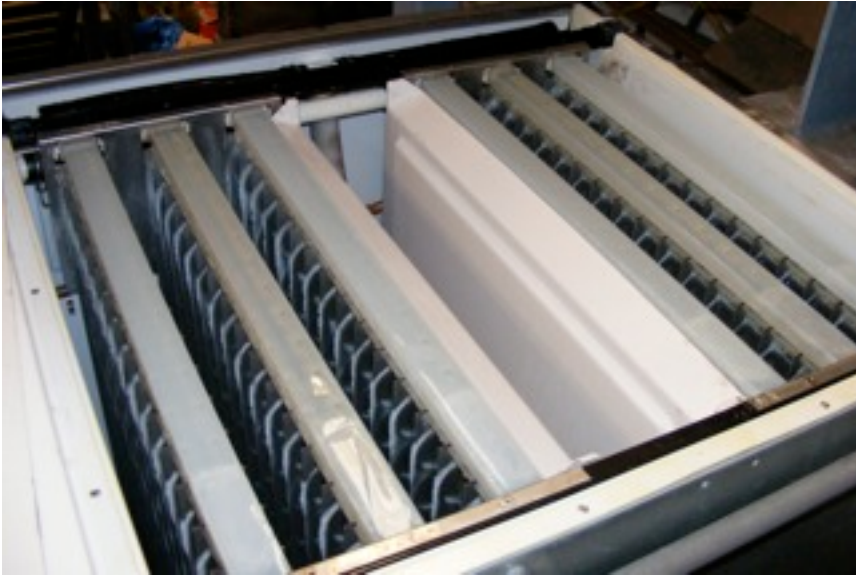
Limescale build up, before HydroFlow, formed typically in 3 months even with the water filtration. After the installation of HydroFlow there is almost no scaling, only a soft gel paste which is very easy to remove.

Maintenance: The property conducts quarterly cleaning and inspection regardless. The ice machines quarterly maintenance and cleaning is taking 1/6 of the time or less, which is a substantial savings in labor. It was also noticed that the ice produced is clearer.
